MSM-Foamguard Airomatic Upgrade kit (item. Nr. 110001614)

MSM-Foamguard Airomatic Problem

MSM-Foamguard Airomatic Solution

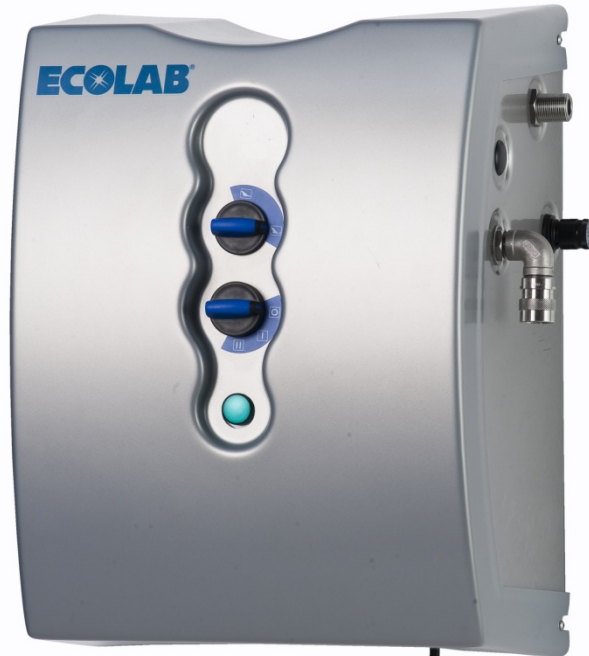
Stationary

We have encountered a water leakage between the pump and the injector when the equipment is using hot water (50-70 °C)

The following pages will illustrate, how to rebuild the MSM and eliminate the problem.

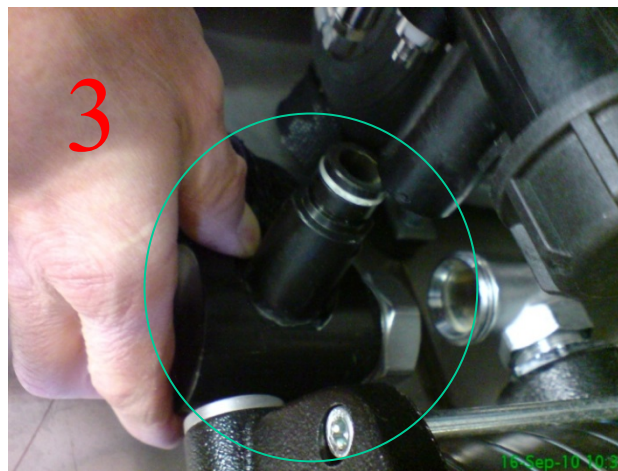
MSM-Foamguard Airomatic Remove parts

1. Remove pin
 2. Loosen nut
 3. Remove manifold
 4. Remove angle
- (Remember to hold contra)
5. Keep connection $\frac{3}{4}$ "
and clean threads

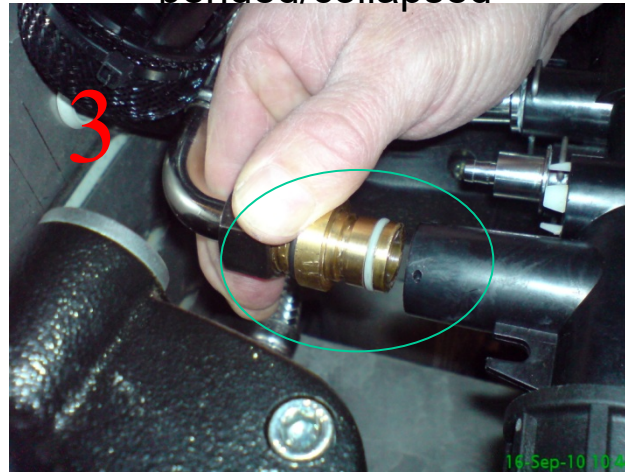
MSM-Foamguard Airomatic Mount new parts

1. Mount a $\frac{3}{4}$ " hose nut on the pump
(Remember gasket "included")

2. Tighten the nut

(Remember to hold contra)

3. Connect the hose to the manifold
(Grease O-ring when mounting)

4. Mount the split

5. Make sure that the hose is not
bended/collapsed

The equipment is now up to date and will be able to handle water temperatures up to 70°C without any problems.
